DISEASES

OF THE

Air Brake System

THEIR CAUSES, SYMPTOMS AND CURE

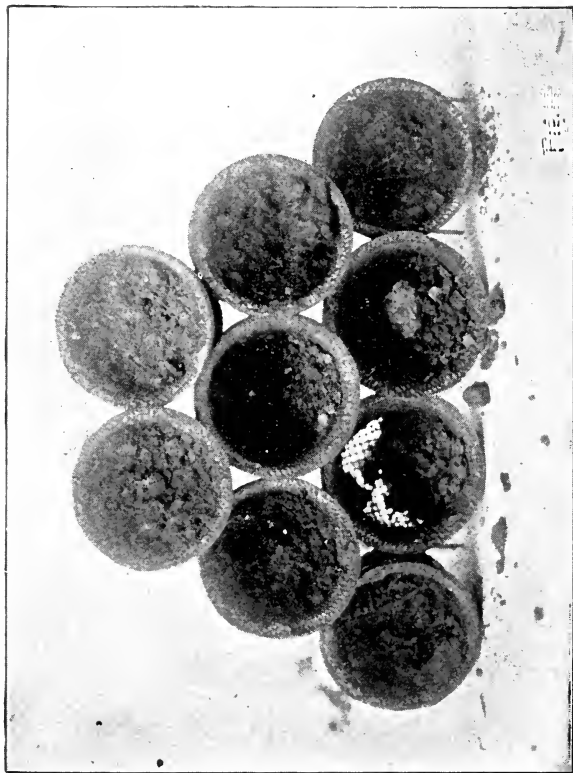
PLATE 18B.

The strainer (Plate 17, No. 16) where the train-pipe connection is made should next be examined, as it sometimes becomes completely stopped with dirt. Strainers in this condition are shown on Plate 18*b*. They were taken from actual service.

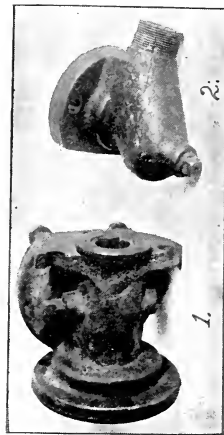
PLATE 32.

What an interesting trio we have in Plate 32. Nos. 1 and 2 are evidently the result of the coupling being caught and smashed between two cars. No. 3, it will be noted, has the upper lug bent downwards, a condition not infrequently resulting from a blow from a link or pin in the hands of some brakeman, in an attempt to stop a leak.

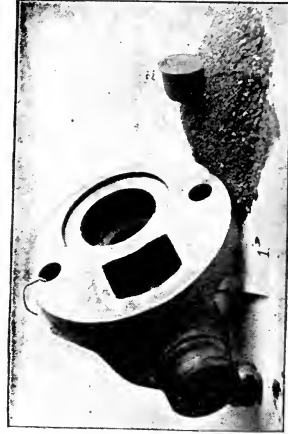
PLATE 35.

Plate 35, though not very beautiful, is exceedingly instructive.
